CALSPAN ON-SITE SCHOOL BUS/PEDESTRIAN ACCIDENT INVESTIGATION

CALSPAN CASE NO. 95-14/3

SCHOOL BUS: 1992 INTERNATIONAL CHASSIS/AM TRAN (WARD) BODY

16. Abstract <p>This on-site investigation focused on the root cause of a school bus/pedestrian accident that resulted in fatal injuries to the 14 year old male pedestrian. The accident occurred during the afternoon hours of 1995, near a designated school bus stop. The pedestrian had exited the bus, however, the adjustable tab to the right drawstring of his jacket became caught between the bifold door and the V-channel in which the door closed against along the right B-pillar. The driver immediately accelerated from the bus stop and proceeded in an easterly direction on the narrow one-lane city street.</p> <p>As the bus accelerated, the pedestrian was probably initially pulled as the drawstring remained caught in the door. He reportedly attempted to run along side of the bus and gain the attention of the driver, however, he was subsequently knocked to the pavement as his jacket was pulled off. The pedestrian's right hand swiped along the right side surface of the bus as he fell to the pavement and was run over by the right rear tires of

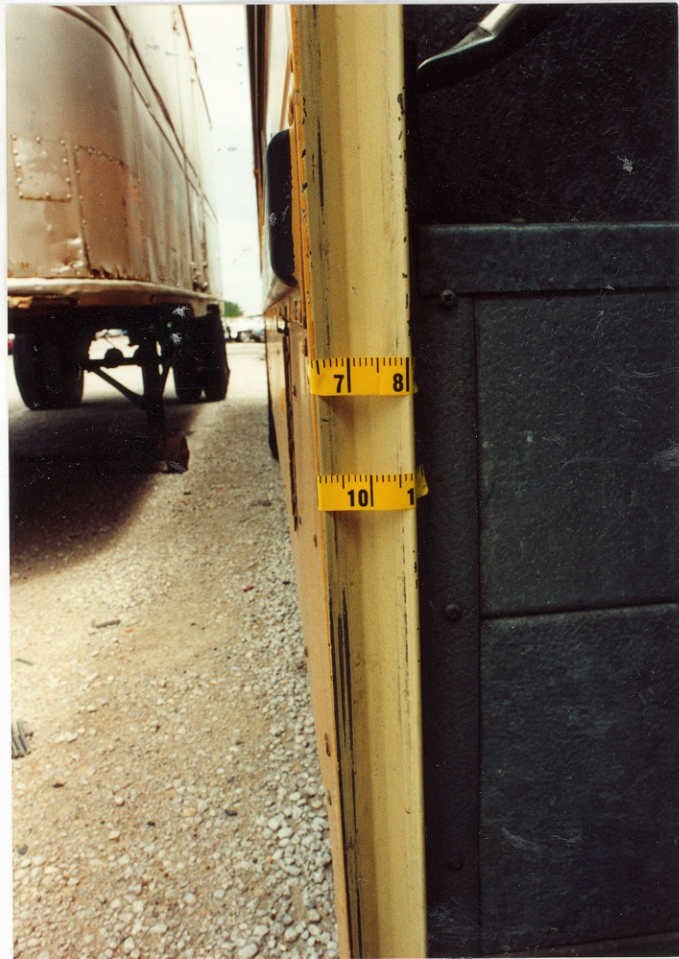
25. Possible area where the drawstring tab was caught between the door and the V-channel.

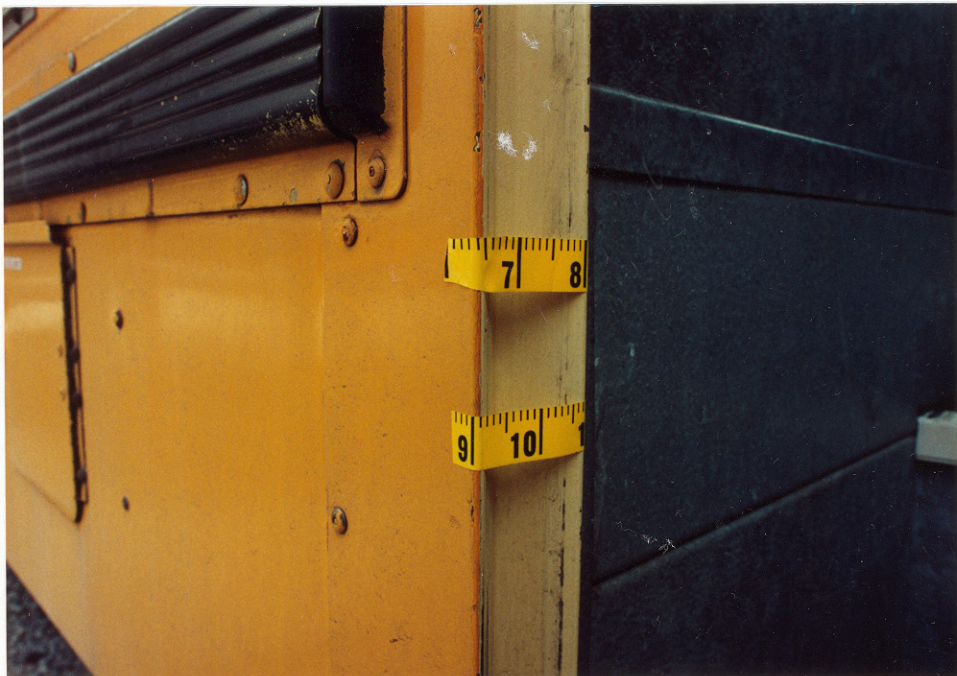
There was no distinct evidence on the bus components of loading or snagging of the drawstring. The edge of the rubber door gasket was straight with numerous abrasive type marks in multiple directions. The V-channel was not gouged or marked from the plastic drawstring tab. There was a fabric-type wipe mark on the exterior yellow painted surface of the V-channel located 32.125-33.375" above the ground. The wipe mark extended 0.25" rearward from the edge of the channel (refer to Photograph No. 26).

26. Faint fabric-type (patterned) wipe mark on right side surface of bus.

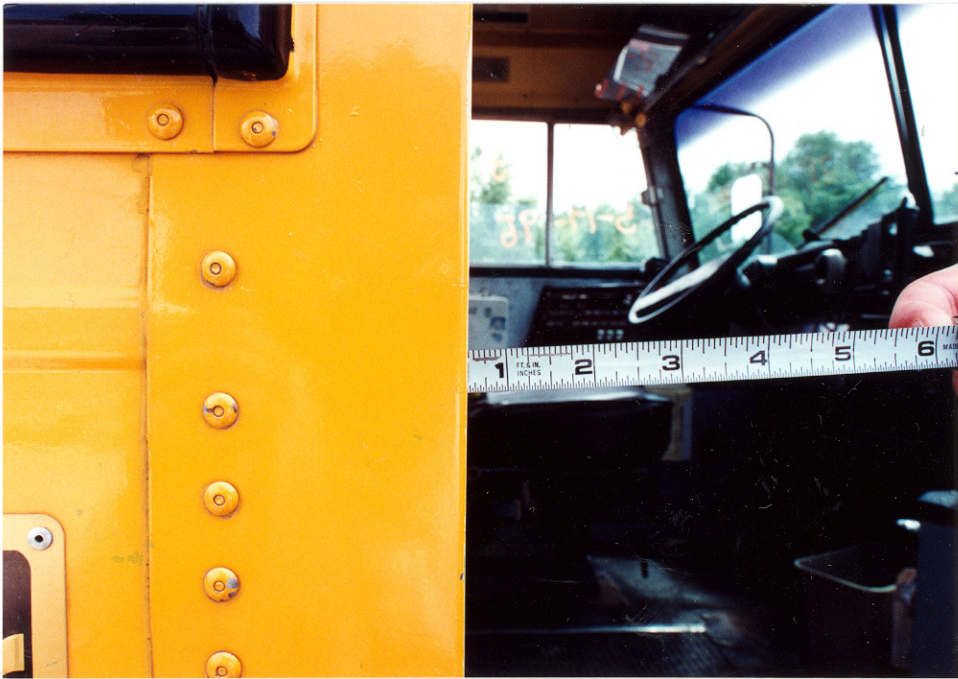
27. Depth (17/32") of the V-channel.

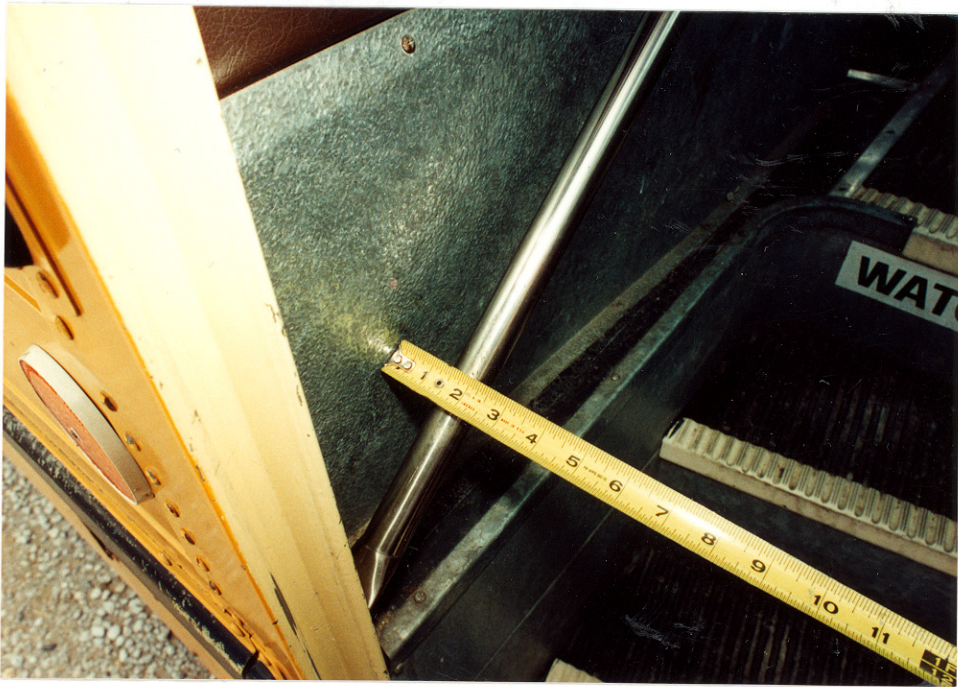
33. Lateral offset between the handrail and the modified placement of the kick panel.

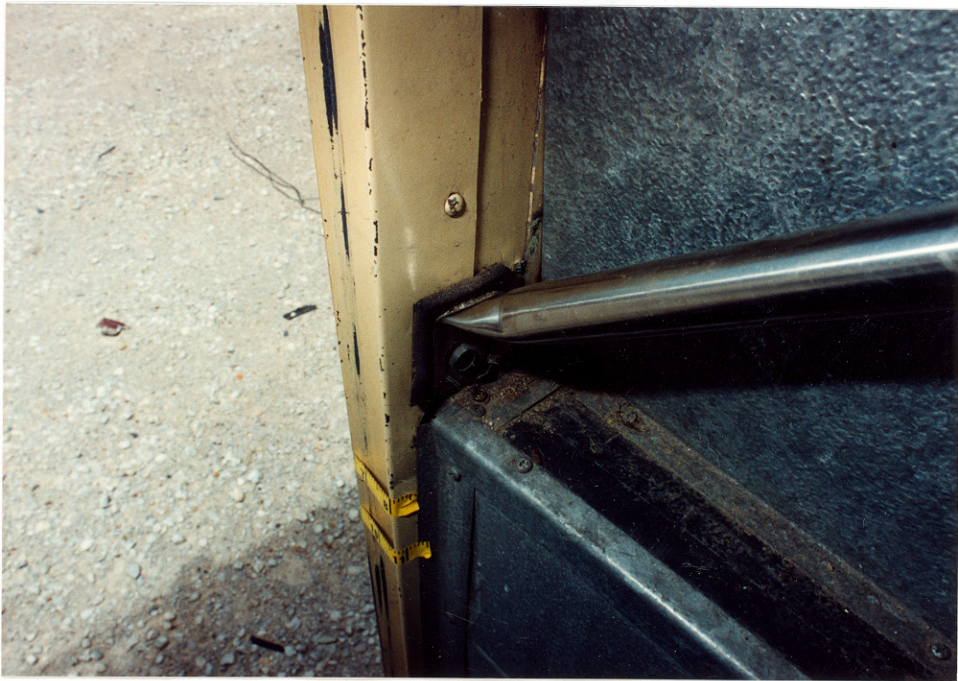
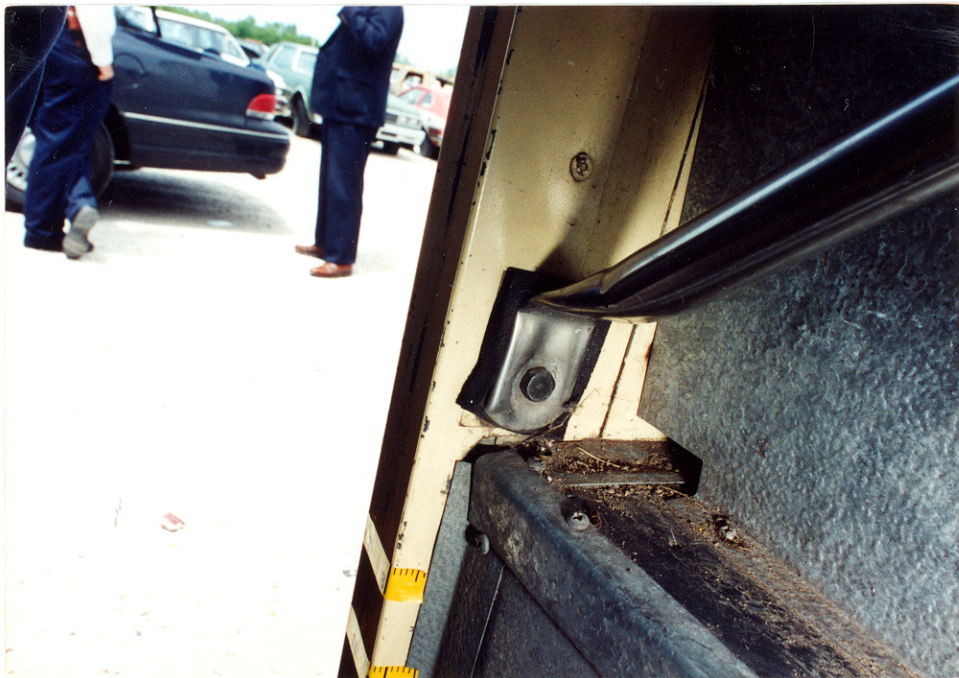
The accident involved school bus had been modified by the contractor prior to this incident. A 2" horizontal x 2.5" vertical soft foam rubber pad was placed between the base of the handrail and the side surface of the bus. In the area of the handrail flange, the foam was completely compressed. The upper edges of the foam pad protruded beyond the handrail flange which was designed to deflect objects (drawstrings, etc.) away from the handrail/sidewall juncture. The installation of the rubber pad is documented in Photograph Nos. 35-37.

35 & 36. Lower attachment point of the handrail with the modified foam rubber pad installed.

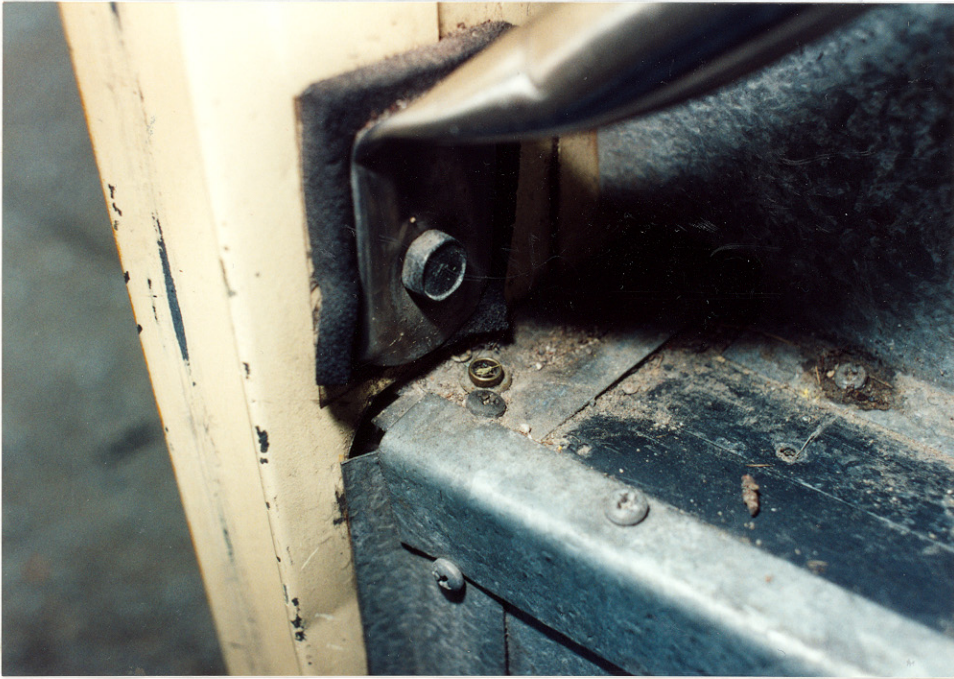
The floor of the school bus extended from the vertical wall at the stairwell to the modesty panel and formed a shelf under the handrail. This shelf was approximately 23.25" in length and tapered from a width of 3.25" at the right B-pillar area to a width of 2.125" at the top of the stairs. During the inspection of the bus, a metallic snap from a clothing item was found on this shelf in the debris against the V-channel/B-pillar area, directly under the lower handrail attachment point. The snap was not related to this accident (refer to Photograph No. 37).

37. Close-up view of the lower attachment point and the installed foam rubber pad. (Note the snap at the base of the handrail attachment point; probably resulted from a previous clothing snag with the handrail.)

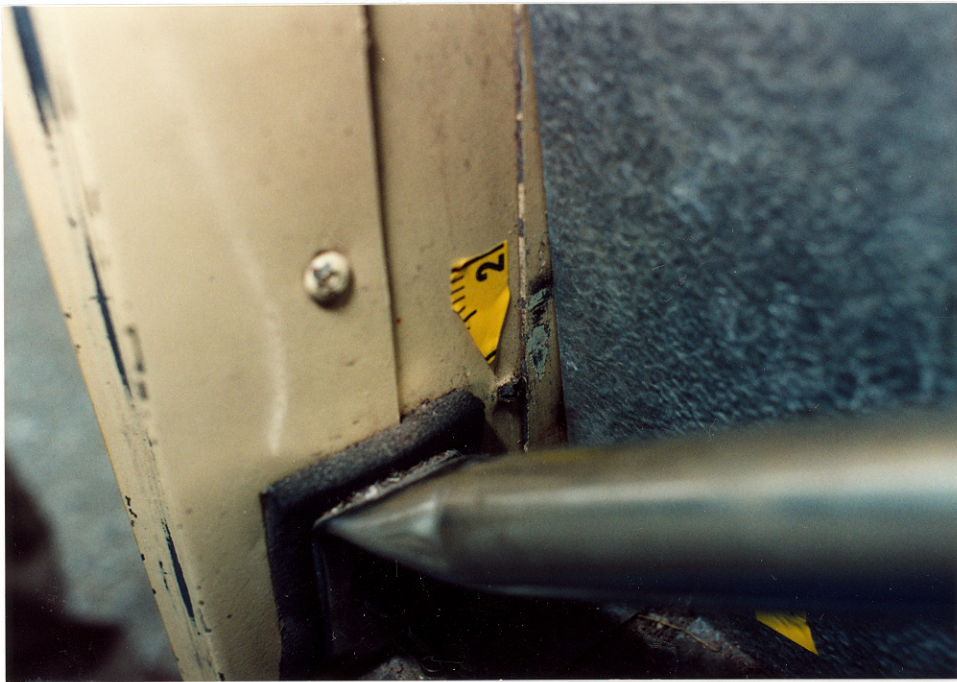
43. Former sheetmetal screw hole with exposed burrs from the initial installation of the kick panel.

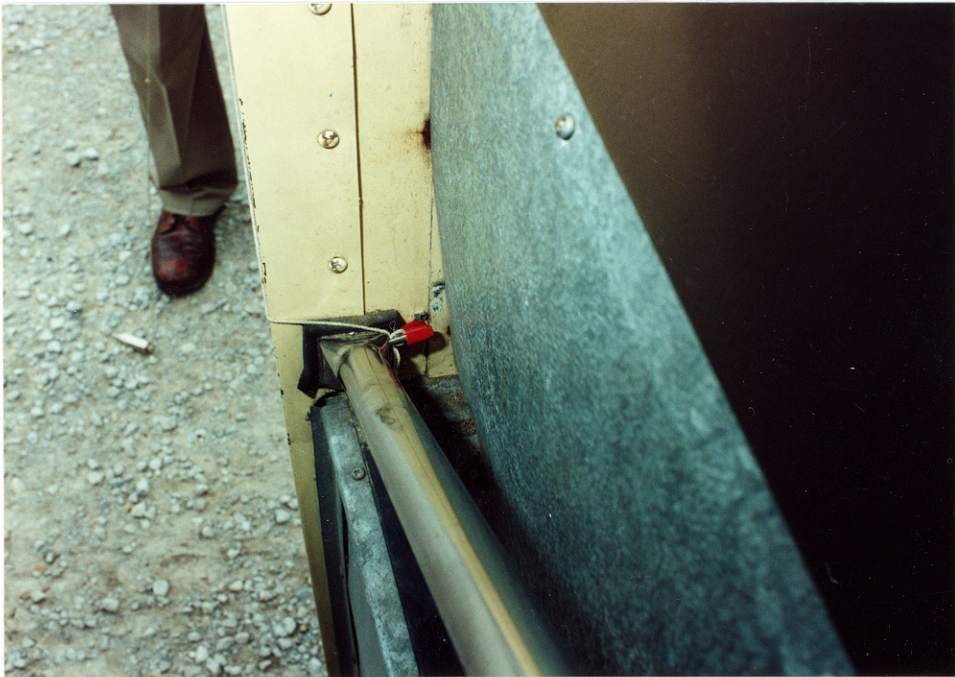
There were two possible components that could have allowed the drawstring to become caught in the bus. The components are the door/V-channel and the base of the handrail. The handrail was ruled out as a possible mechanism by two sources; the bus driver's statement that he observed the jacket (drawstring) fall as he opened the door and the inability to recreate a snagging of the actual drawstring following numerous tests over the handrail configuration. The large tab and the rounded corners on the tab prevented the drawstring from becoming snagged on the rail. The modified foam rubber pad contributed in deflecting the tab away from a possible snag point. Another style of drawstring tab could become snagged between the rail and the previously identified screw hole as documented in Photograph Nos. 44 and 45.

44. A "drawstring" constructed from chalkline and an alligator clip became snagged between the bottom of the handrail and the burrs at the screw hole on the first test.

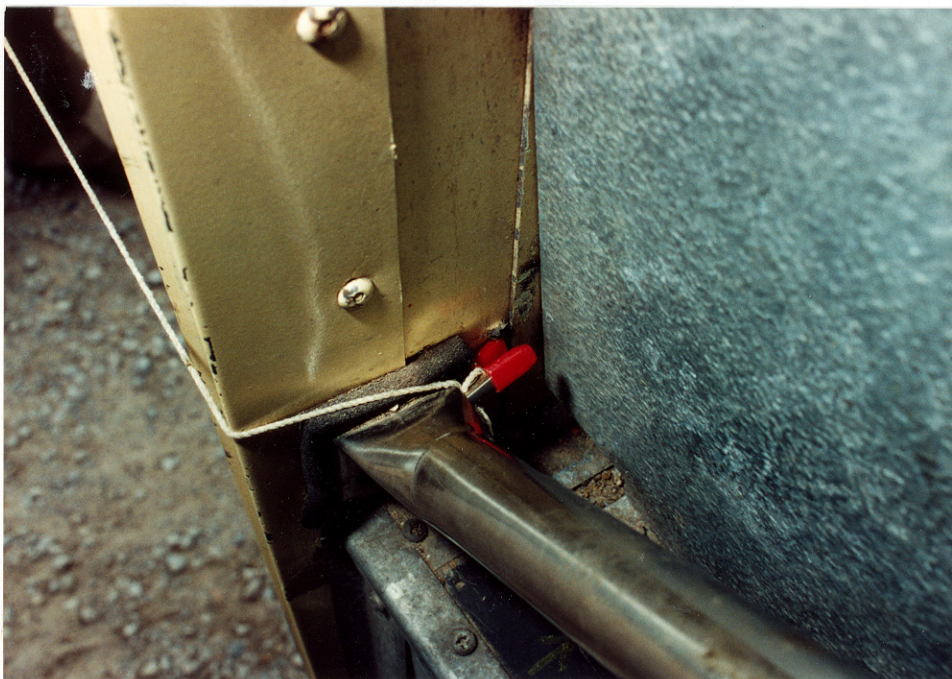
45. Close-up view of the snagged alligator clip.
(The actual drawstring and adjustment tab from this accident would not snag at this point following numerous attempts.)

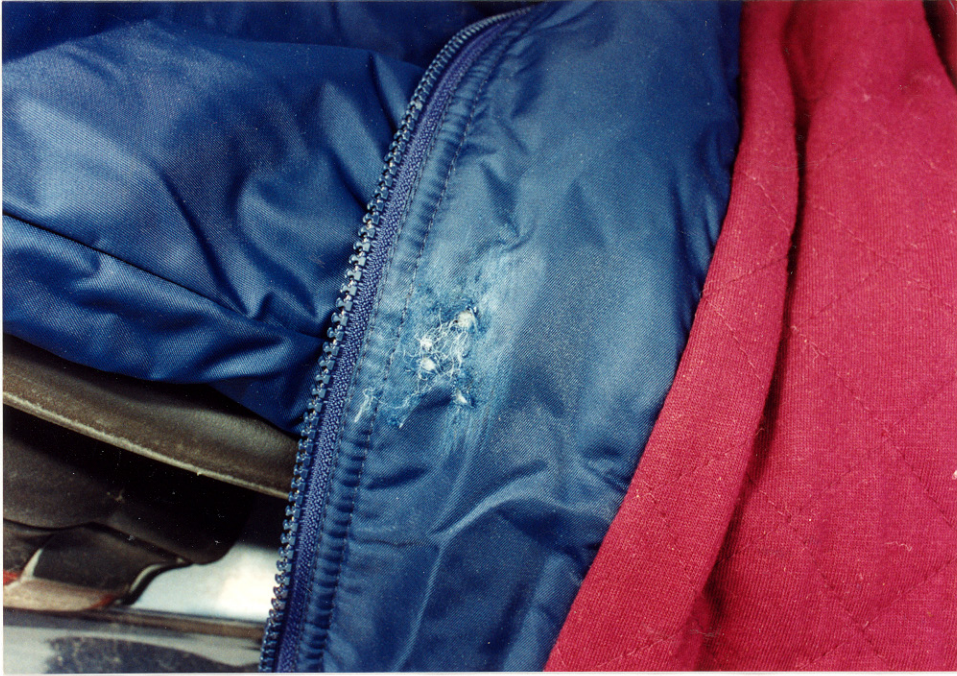
49. Abrasion to the right inner surface of the jacket from probable road surface contact.

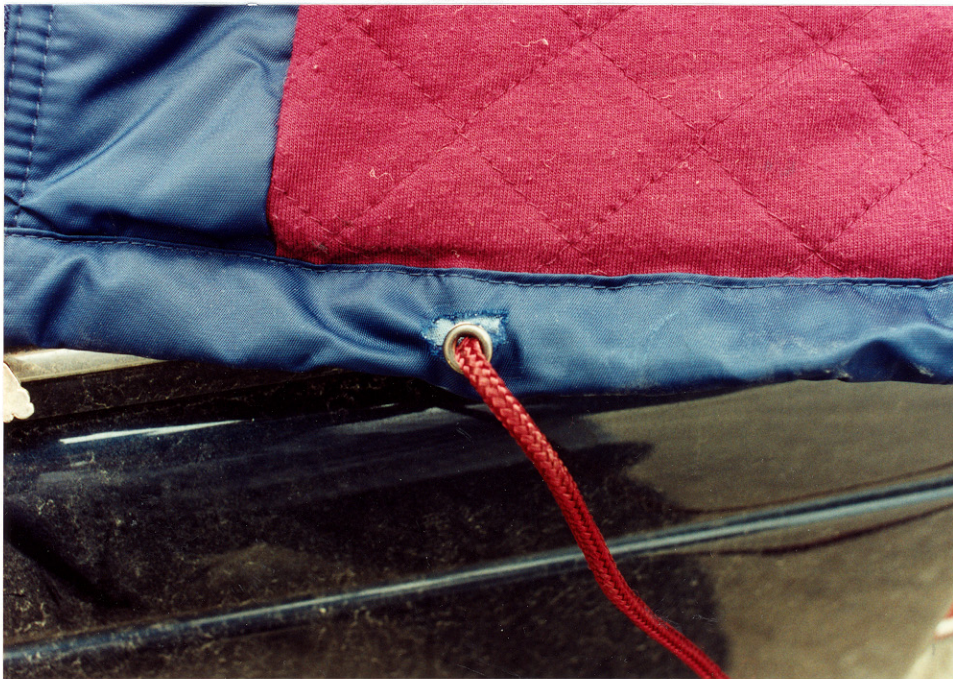
51. Torn fabric around the right side grommet of the jacket.

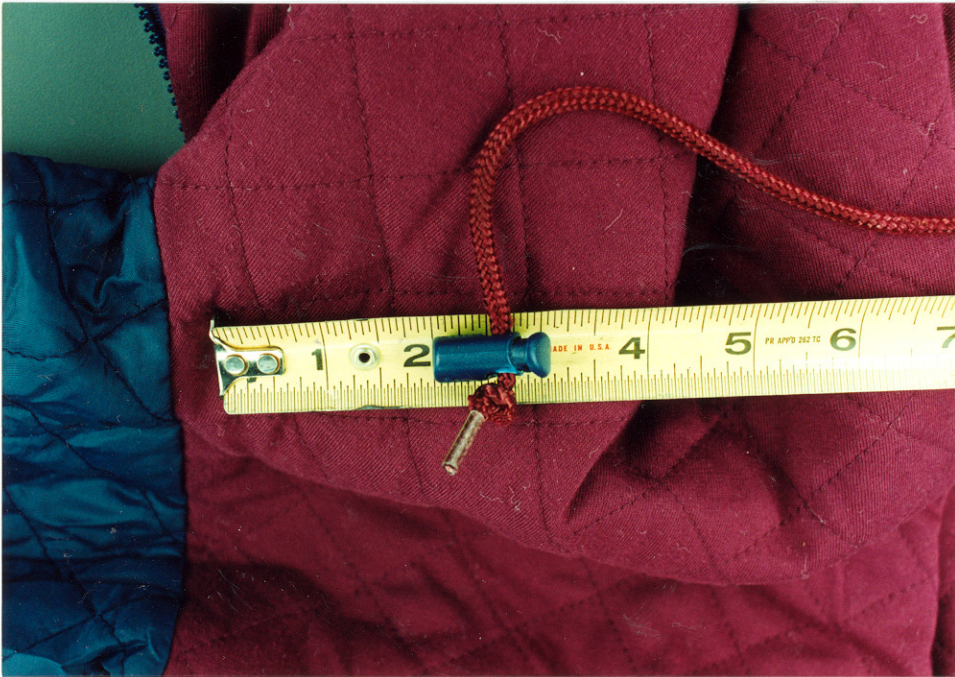
55. Right side adjustable tab which became caught between the door and the V-channel.

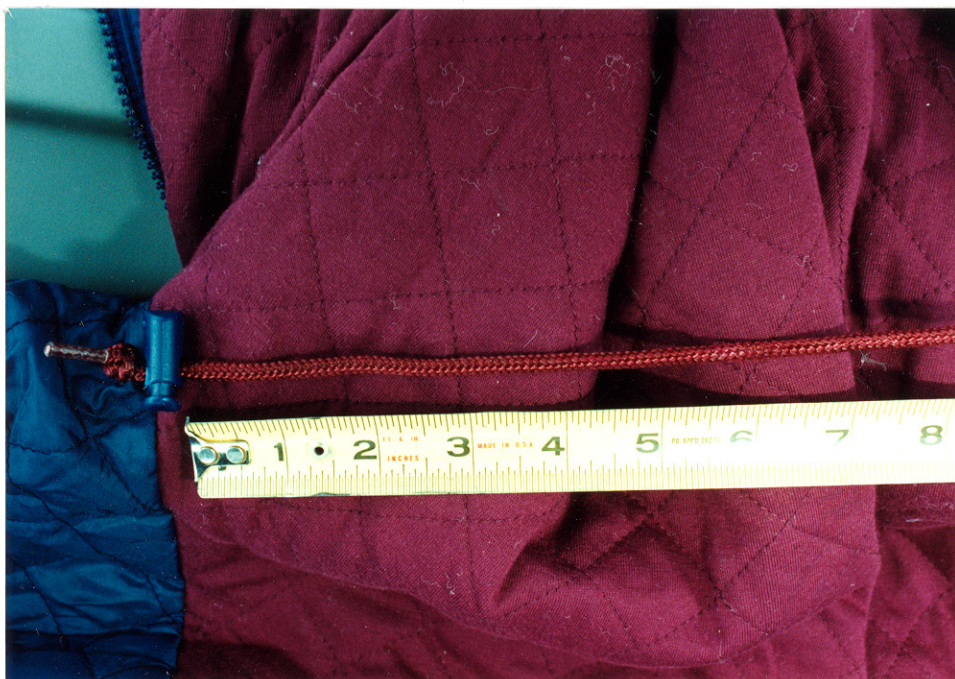
58. Snag with a possible paint chip in the drawstring at 5.5-6.0" above the adjustable tab.

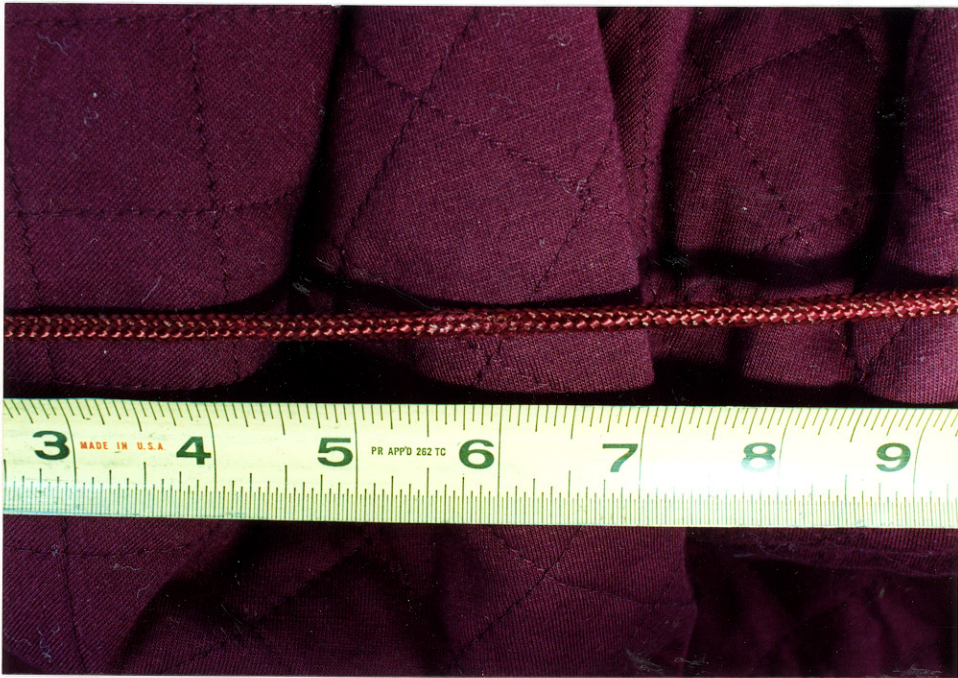
59. Close-up view of the drawstring snag.

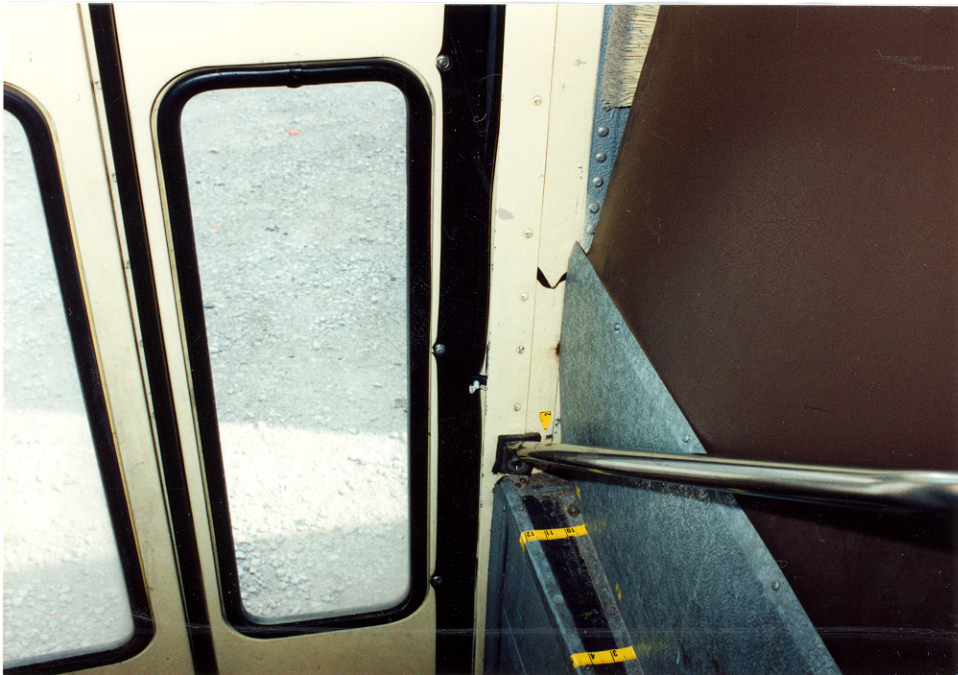
the door gasket and the V-channel. This pull test procedure is documented in Photograph Nos. 60-67. Additional pulls were performed with the tab positioned vertically and the cord disengaged at 50-75 lbs. of force.

60. Recreation of the drawstring tab caught between the door and the V-channel.

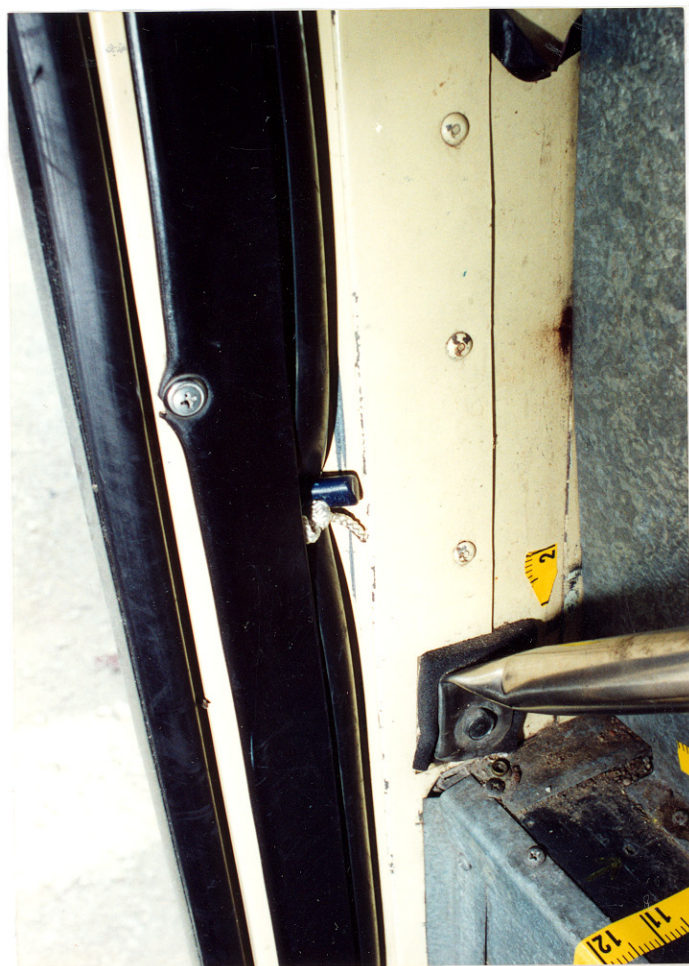
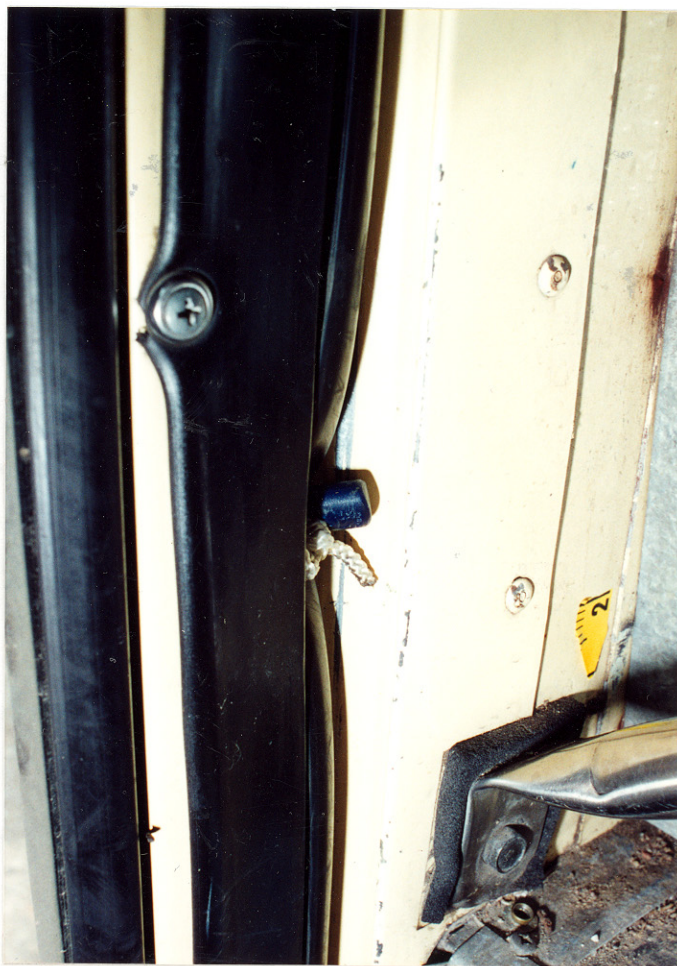
61. & 62. Close-up views of the drawstring tab caught between the door and the V-channel.

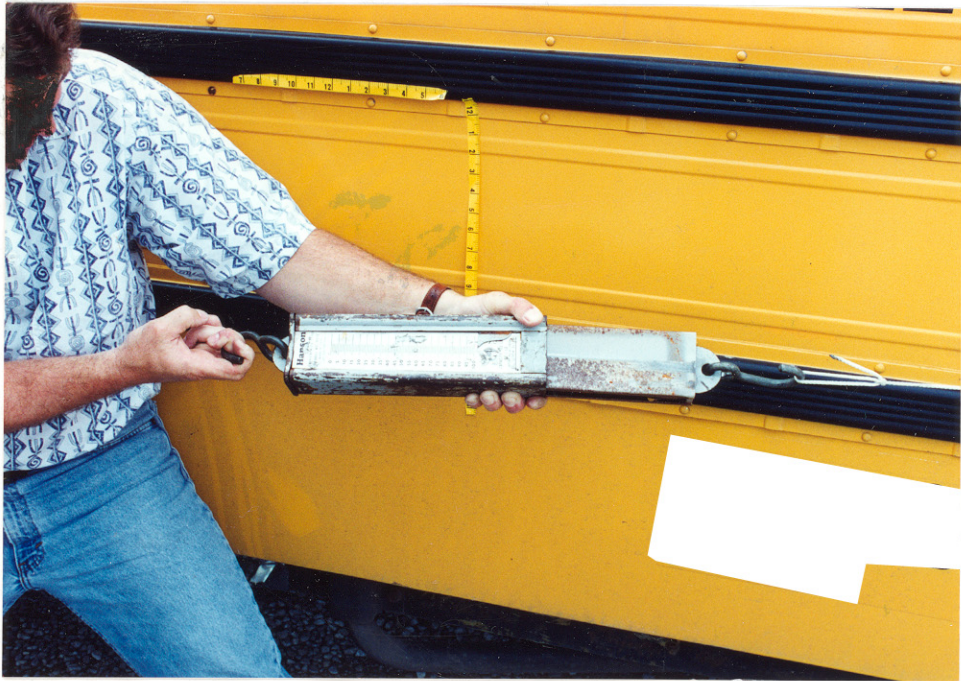
67. Pull force exceeding 100 lbs. as recorded on spring scale.

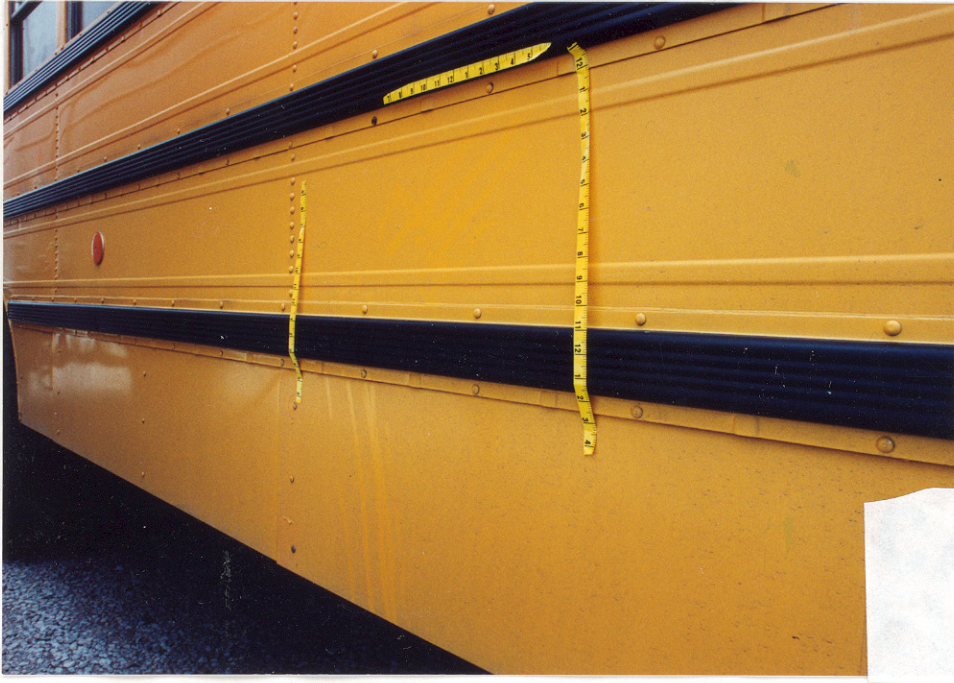
69. Pedestrian's right hand wipe mark on side surface of bus.
Wipe mark was located 74.5-90.25" rearward of the B-pillar.

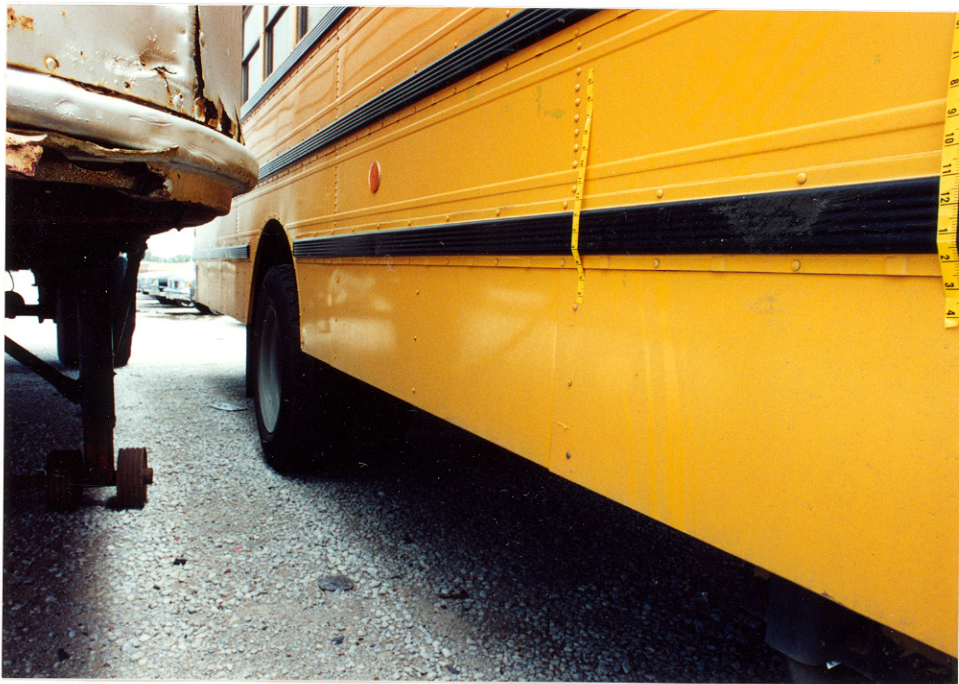
72. Right rear dual wheels which ran over the pedestrian.
